# **LUTHERAN TRAINING INSTITUTE**

## **ASSESSMENT REPORT**

### **LUTHERAN TRAINING INSTITUTE ALUMNI ASSOCIATION OF THE AMERICAS (LUTISAA)**

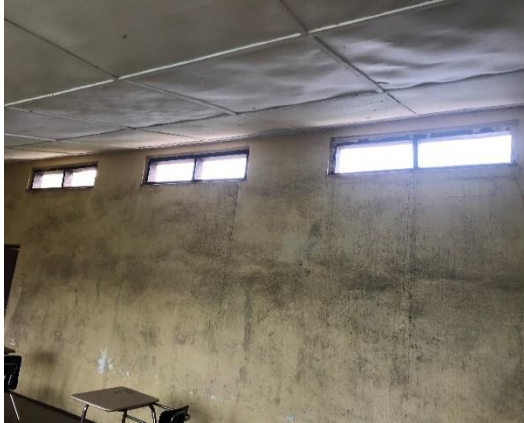
The overall conditions of the doors and frames are poor and need replacement. The window screens and frames are in similar condition as the doors. There are signs of failure in the ceiling joist. The ceiling or hard board are damaged and falling. There are signs of water leak on the existing hard board.

Photo 01: Showing inside classroom

Recommendation: the roof and portion of wooden truss, and the ceiling are to be replaced. The bill of quantities listing the cost is attached. (**See Photo 1 & 2**)

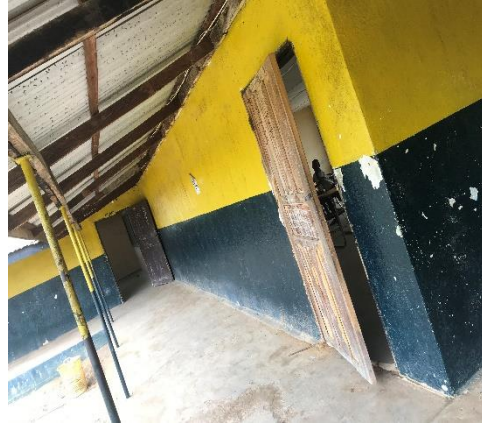
The corrugated zinc alloy has signs of minor to major corrosion and are (failing) in some areas of the roof. The roof needs replacement along with some of the wooden truss.

Photo 02: Hallway of classroom #1

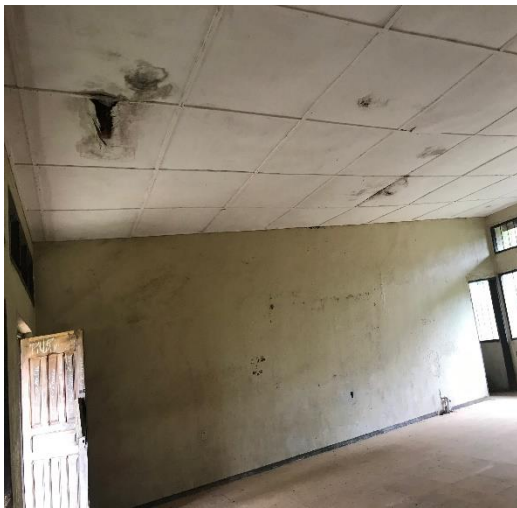
The corrugated sheeting of roof is in fair condition as there are signs of leaks on the ceiling.

Photo 03: showing damage ceiling & sign of leakage

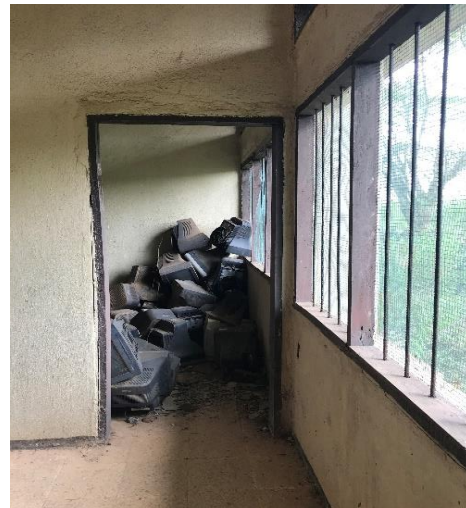
To further improve the area, the walls should be painted, the electrical system (wiring) and electrical fixture should be checked; the plumbing and piping system is not functional and should be checked and replaced. The ventilation system, which consists of window(s) with screens and frames, is in very poor condition and should be replaced.

Photo 04: showing window, door and wall

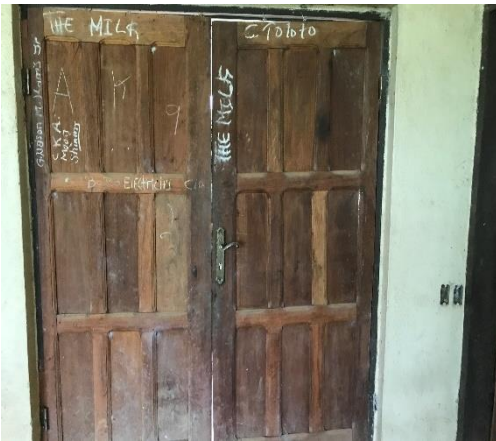
The lab has twelve doors which include three double leaf panel doors, three single leaf panel doors and six plywood doors that are severely damage. To adequately protect this unit, the three exterior double doors should be replaced with steel grid doors. (See Photo 3-8).

Photo 05: showing door that need to be changed

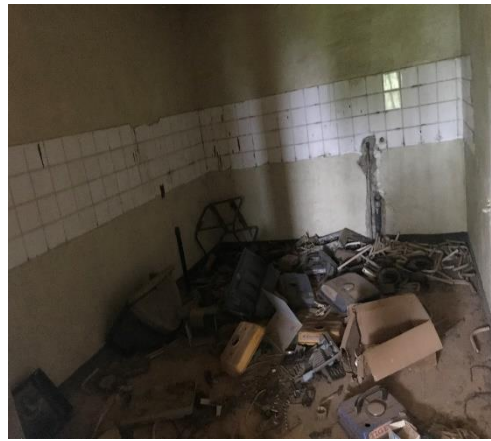
The present condition of the interior walls is fair, and the floor condition is poor. Due to the high foot traffic in this area and chemical spill, the floors and walls need to be finished with terrazzo and ceramic tiles.

Photo 06: showing room with broken wall tile

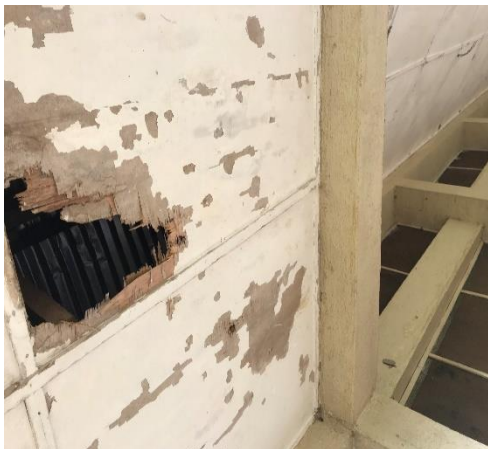
Photo 09: showing damaged ceiling

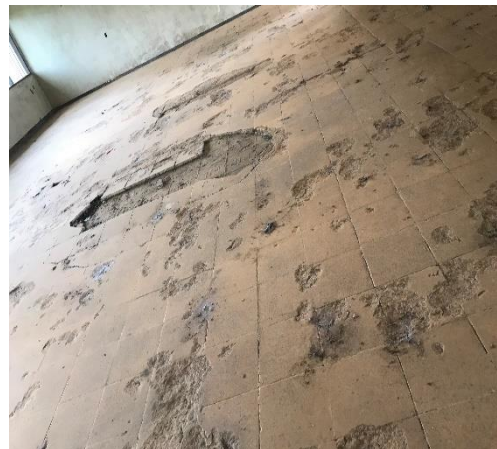
Photo 08: showing damaged terrazzo floor tile

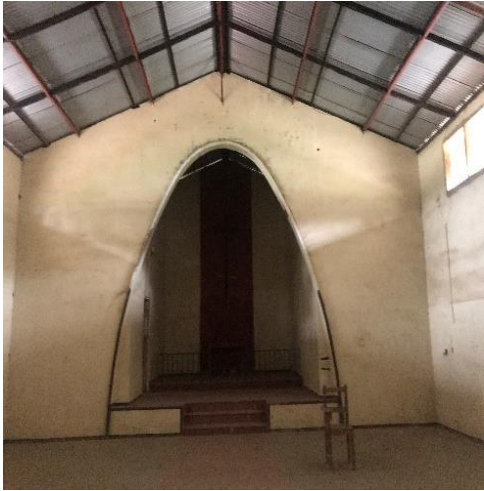
The aluminum corrugated roofing sheet on steel trusses are in good condition and there is no sign of leaks and/or corrosion on the trusses. There are no ceiling or ceiling joists installed in the entire Chapel/Auditorium.

Photo 09: showing walls, roof and no ceiling in chapel

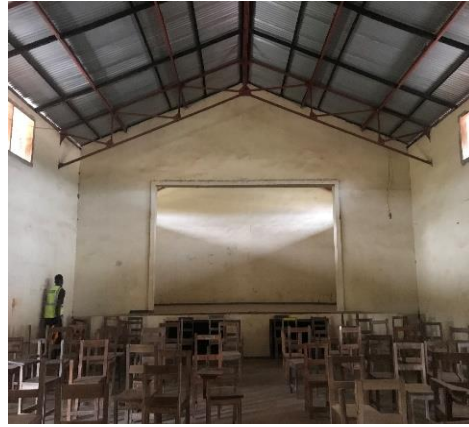
Photo 10: Showing walls and roof

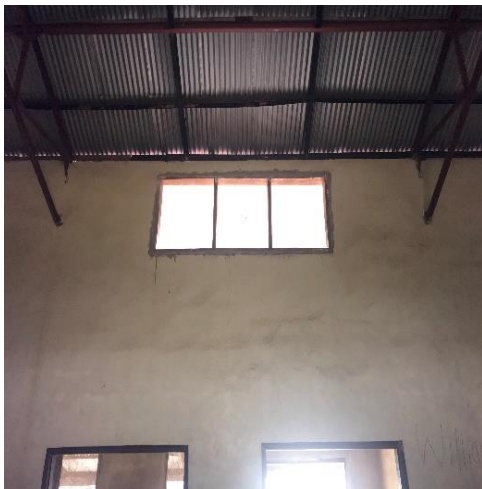
Photo 11: showing wall and window

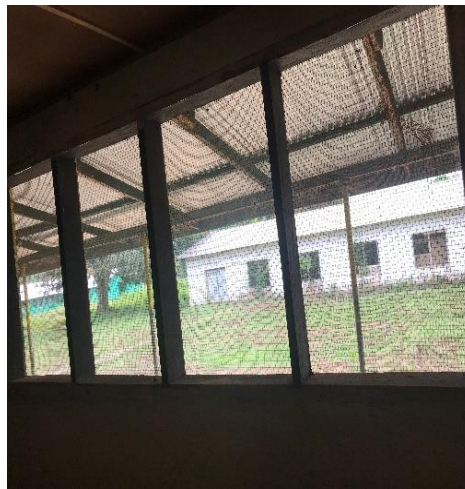
Photo 12: showing window screen

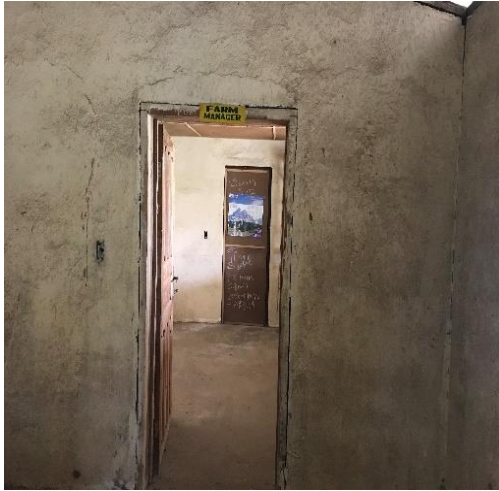
Photo 13: showing wall and steel door frame

There are several doors and frames that are poor conditions. For security reasons the main entrance door should be replaced with steel door complete with frame. Presently, all the doors are not secure and need new locks. The windows are in poor condition and need to be reconditioned or completely replaced with new windows. The electrical wiring and electrical fixtures (receptacles, sockets, switch and ceiling lights) are partly functioning and need to be upgraded and/or replaced.

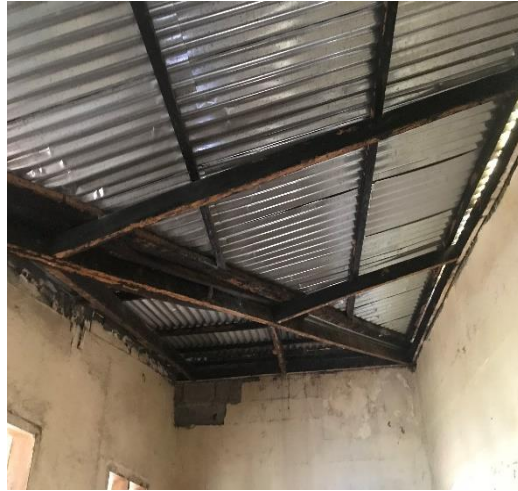
Photo 14: showing roof without ceiling

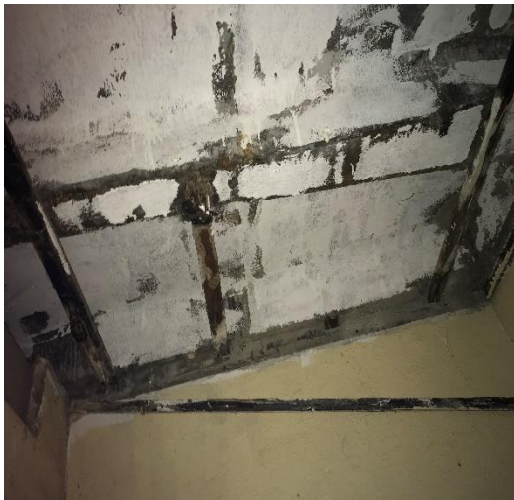
The slab over the portion of the Chapel/Auditorium, where the offices are located, has signs of minor cracks and exposed re-bars. The re-bars show signs of carbonation and minor corrosion. **The concrete appears hollow and has begun to spall due to earlier water damage.** There are major structure failures in the walls and slabs of the upper floor section of the Chapel/Auditorium. There are signs of cracks and frail in the vertical and horizontal structures which are visible from both exterior and interior locations.

Photo 15: showing rusted rebar from slab

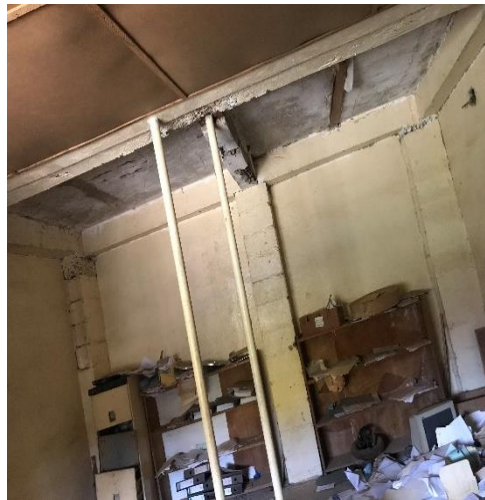
Photo 16: showing slab, column that have cracks

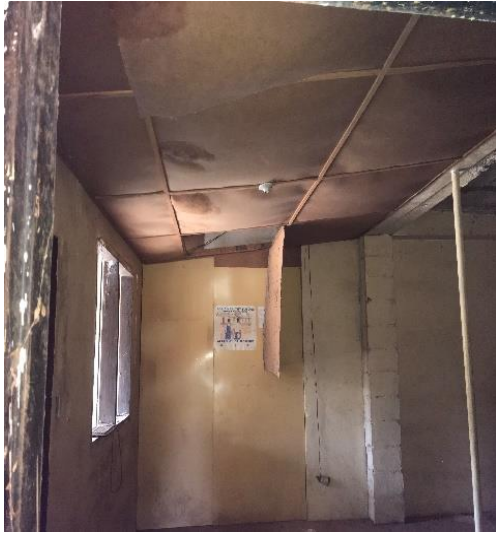
Photo 17: showing damage ceiling

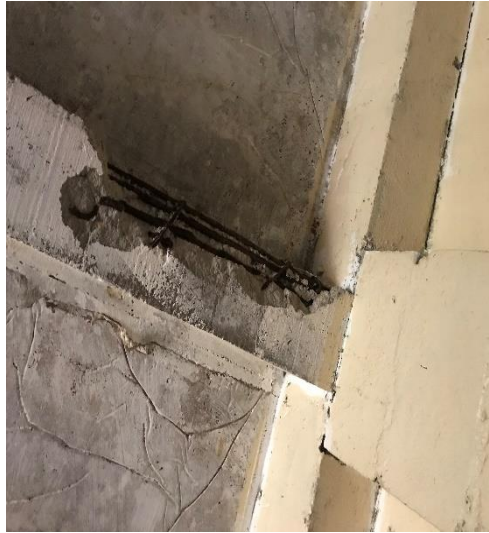
Photo 18: showing cracks on slab and rebar

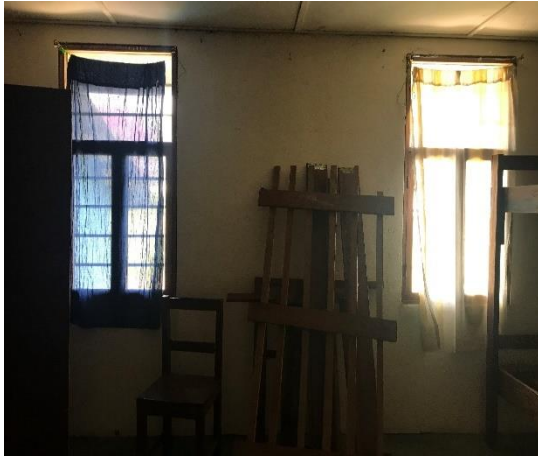
Photo 21: Showing windows in the dormitory

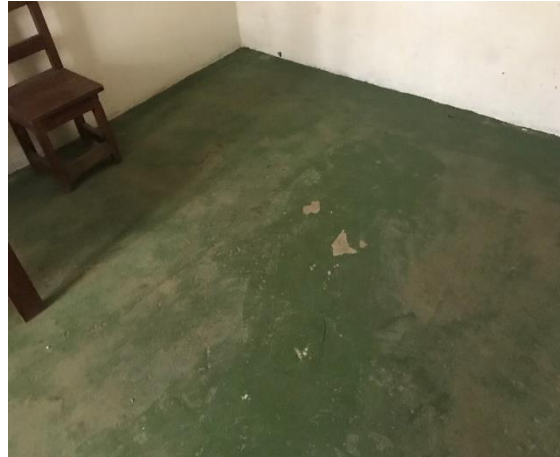
Photo 22: Showing Floor in the dormitory

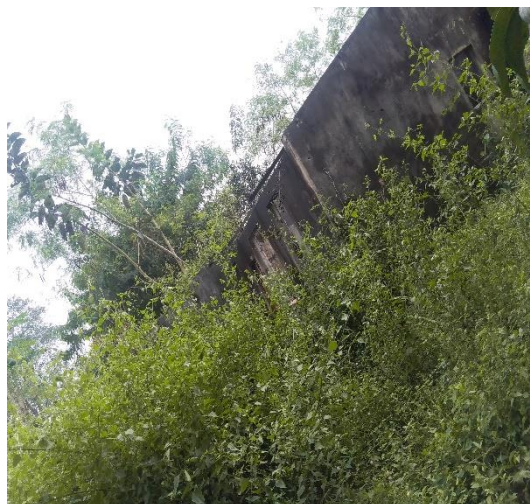
Dormitory #3 is an unfinished structure that is overcome by vegetation growth that has seriously undermined the integrity of the structure from the foundation to roof level, rendering the structure unusable. Therefore, it is recommended that the structure be demolished. Please note that early construction was not completed due to the Liberian conflict of the early 1990's to post war Liberia. **See Photos (21-28)**

Photo 24: Showing female dormitory that need to be demolished

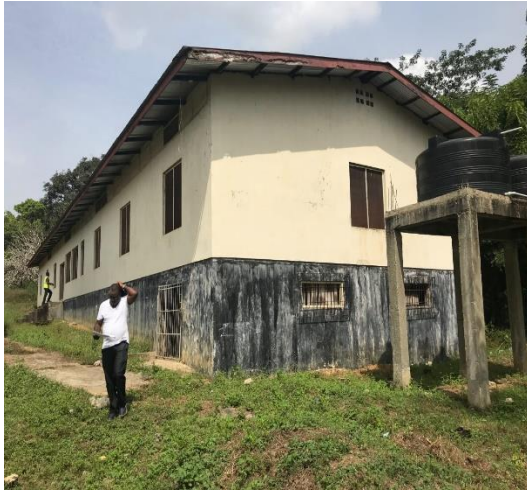
The roof on this unit shows major signs of corrosion and leaks in multiple spots is visible to the eyes. A thorough inspection of the trusses must be conducted for further verification. The removal and replacement of all affected truss is required. The areas of the ceiling boards that warrant strengthening and replacement must be replaced.

Photo 25: showing senior female dormitory

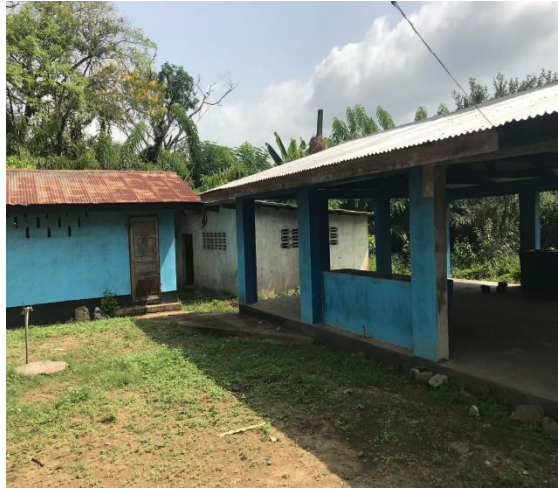
The bathroom is in poor condition. The supply lines, waste lines and floor drains are to be replaced due to clogging from debris and an extended period of being unused. The faucets and shower diverters are corroded, there are missing wall and floor tiles and all the water closets (toilets) and face basin are damaged and

Photo 26: showing laundry & bathroom for female

very unsanitary. All connecting accessories are also damaged. Based on this observation, the entire bathroom facility must be demolished and renovated.

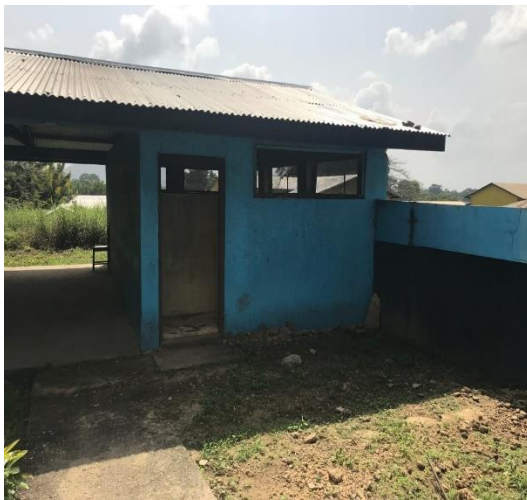
Photo 27: showing shower unit for female

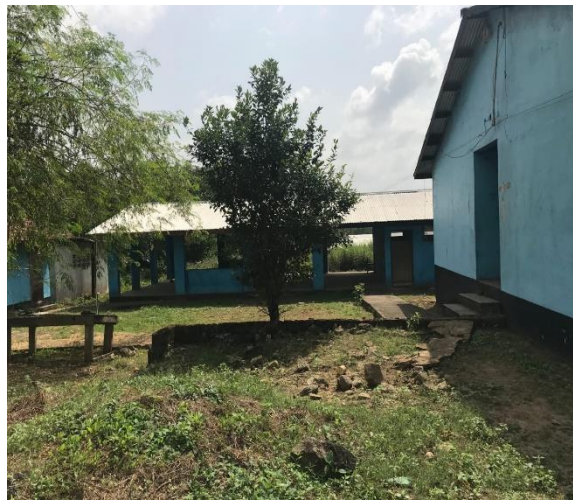
Photo 28: showing back of female dormitory

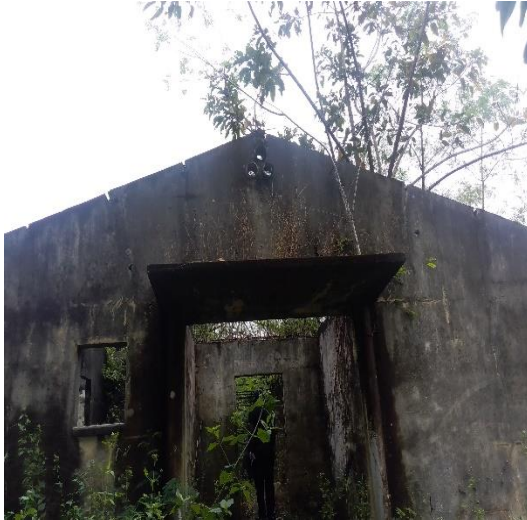
Photo 29: Showing boys dormitory that need to be demolished

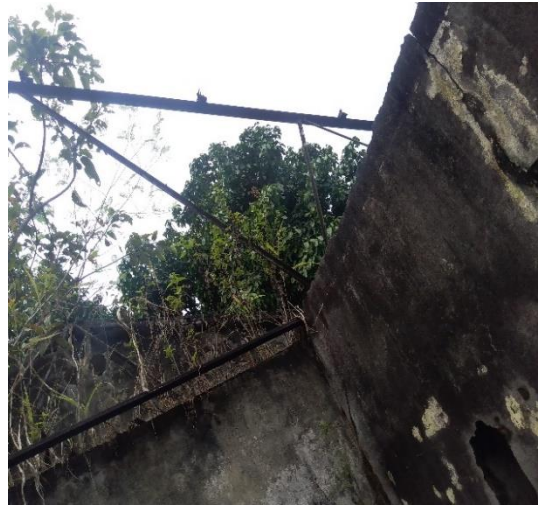
Photo 30: showing rusted steel trusses

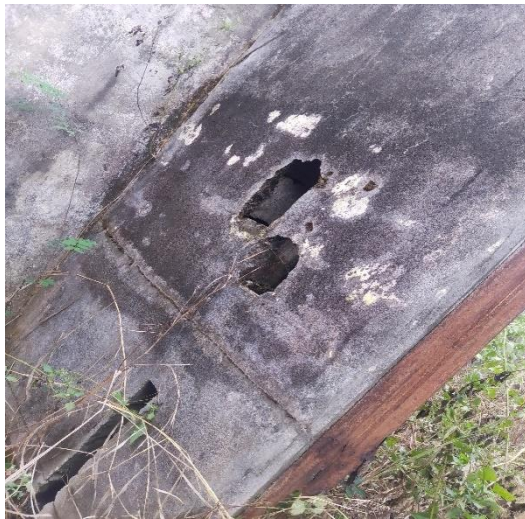
Photo 31: showing holes in the wall

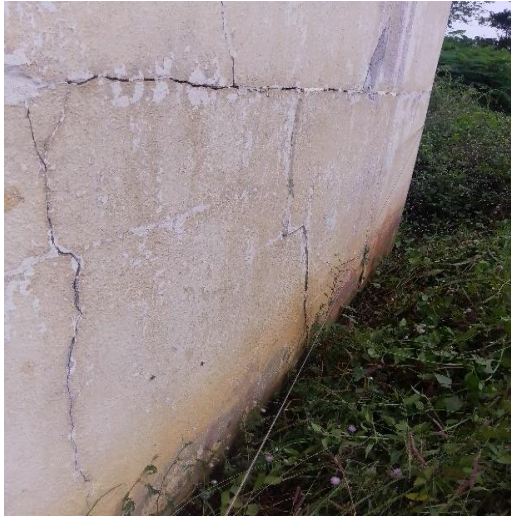
The main male dormitory consists of two wings namely, right and left wings. The right-wing houses twelve (12) rooms whilst the left-wing houses (9) rooms. There are eight (8) closets and study area located in the left-wing. The building also has a living quarter for the Dean of boys with a living room, shower, and bathroom unit. The male dormitory that is presently being occupied by the students is structurally sound except for a hairline crack at an area in the right-wing section that can be readily repaired.

Photo 33: showing cracks on the boys dormitory

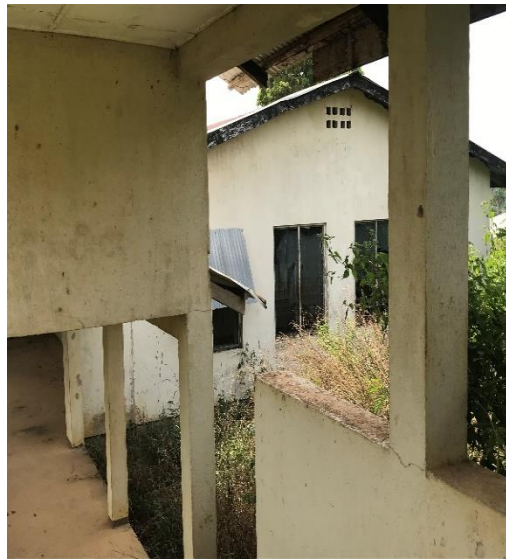
The roof on this building needs to be dismantled and replaced due to major deterioration. There are signs of leaks and the aluminum corrugated roofing sheet is rusted. The wooden trusses and members need to be removed and all ceiling boards removed and replaced. (See Photo 34)

Photo 34: showing library @ the far right

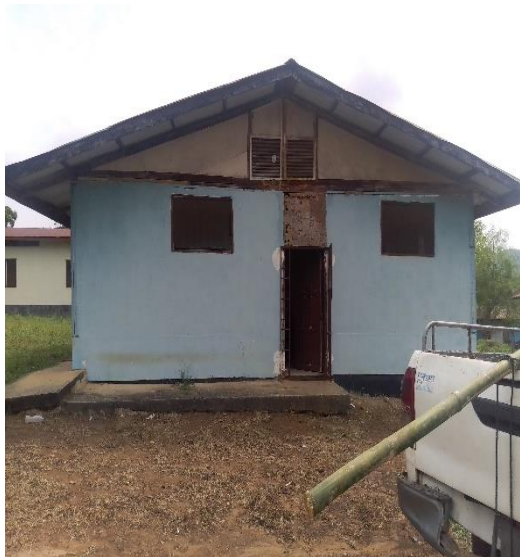
The walls are in a structurally good condition and the surface of the exterior and the interior need to be prepped and repainted. The roof is in poor condition due to deterioration from carbonation and weather. All truss members and roof covers are to be replaced and termite proofed. Currently, there isn't any ceiling covering in the building and which is needed to prevent dust destruction to the ICT equipment and sewing machines.

Photo 35: showing home economics building

traffic floor paint for aesthetic and durability. The windows and doors are in poor condition and need replacing. In order to secure the equipment and materials, the building requires steel metal entry doors with security locks. (See Photo 35)

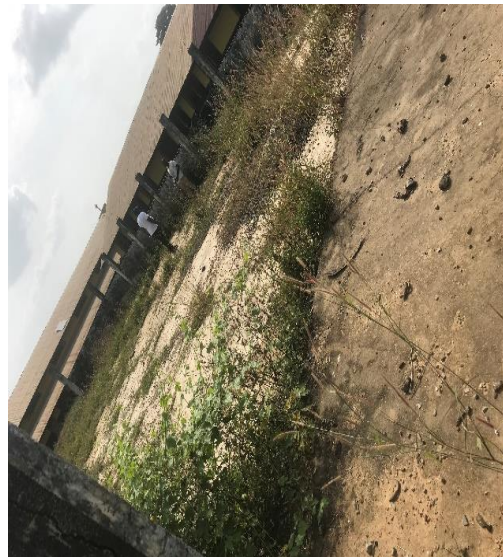
Photo 36: showing damage floor

It is recommended that the existing student center building be demolished due to total structural failure. A new building design drawing is being submitted for consideration. (See Photos 36-38).

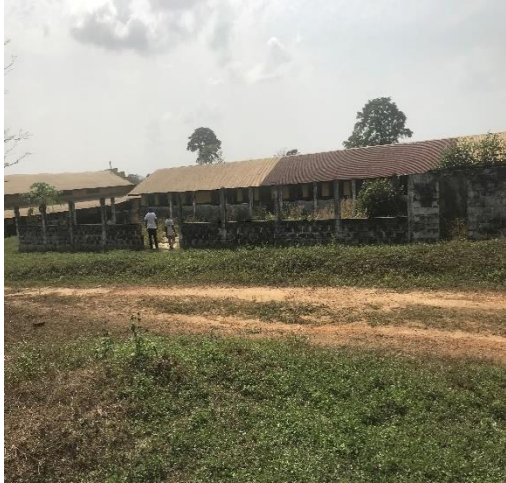
Photo 37: showing student center

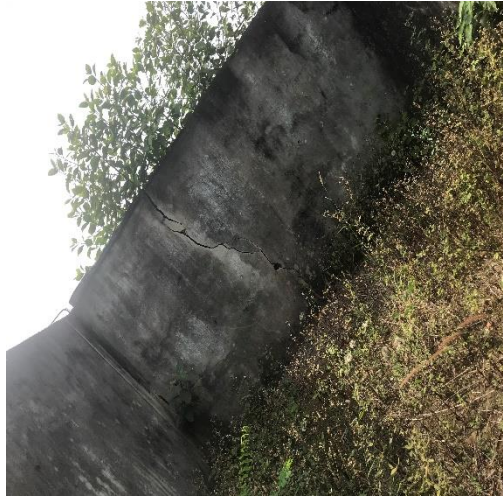
Photo 38: showing crack on wall of student center

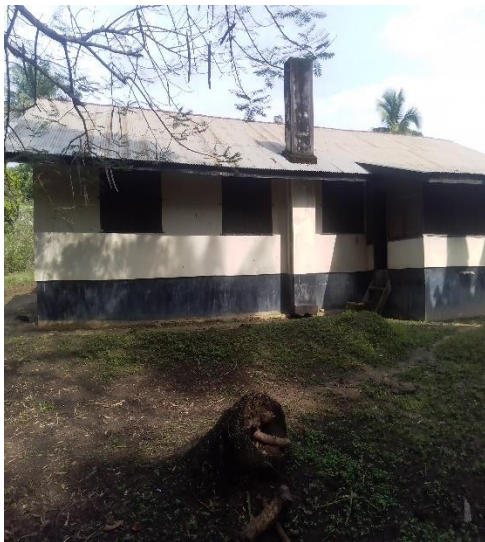
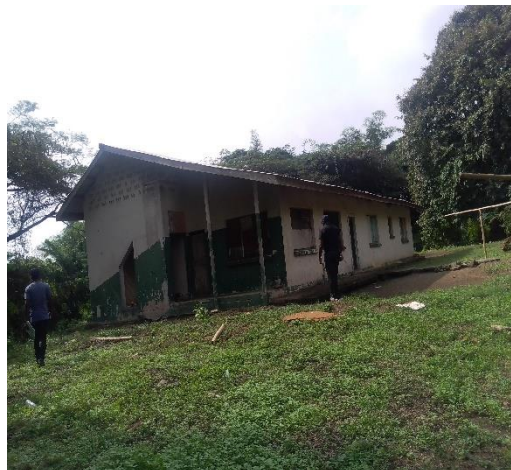
This unit has three unique designs which consists of four bedrooms, living room, dining room, kitchen etc. The family quarter unit walls are structurally good. One unit has been abandoned and there is no roof, door, and window.

Photo 39: showing faculty residence

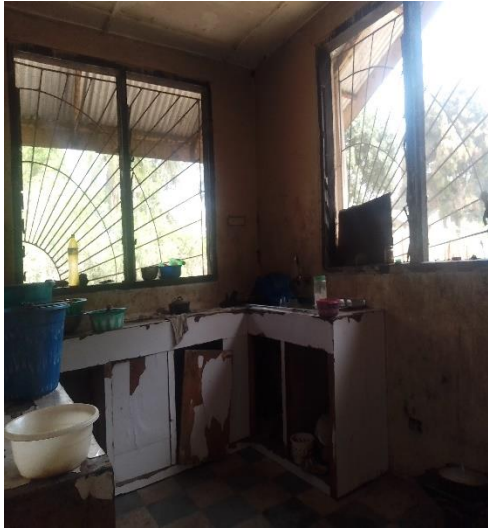
We observed that all the windows, doors floor, ceiling and wall surface are in poor condition. All windows (louver window, screens and frames), doors (frames and panel and plywood doors) have been damaged by termites, not locking and/or improper closing of the doors, as well as some doors have been removed from the frame. All doors, frames, locks and/or hinges need to be replaced. The paint on the wall is fading; the walls need to be scraped and painted with approved paint. Some of the dwelling have tiles, with missing pieces whilst others do not. The floor condition is good but there is a need for new tiles to be installed in each house.

Photo 41: showing kitchen (wall, window & cabinet)

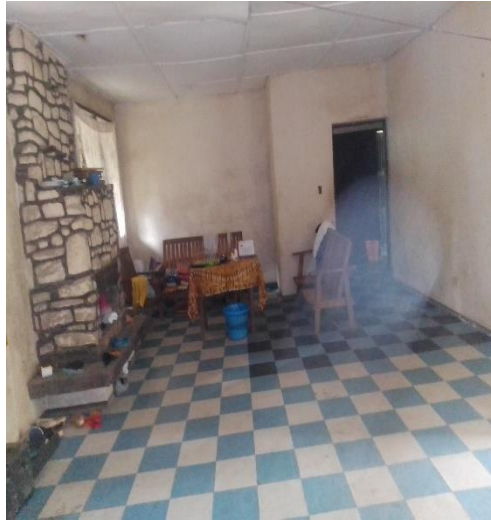
Photo 42: showing living room (floor, fire place and wall)

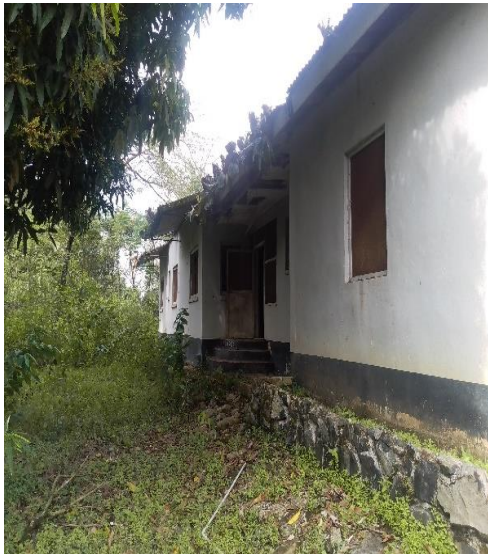
Photo 43: showing exterior of faulty residence

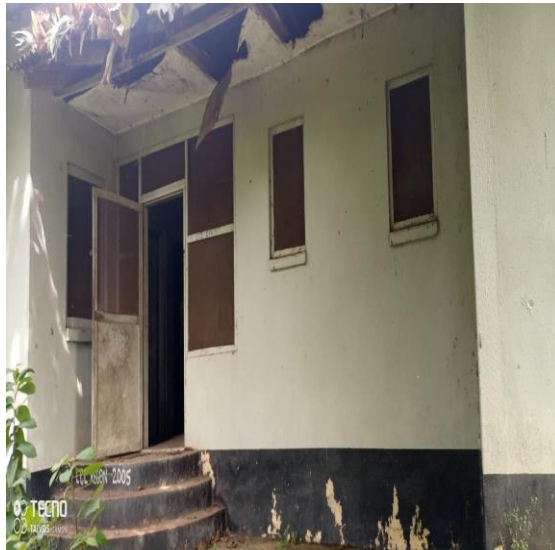
All the roofs on the single-family quarters are in very poor conditions. Damages were due to rust and signs of leaks. It is recommended that all the roofs along with its members (wooden) be replaced.

Photo 44: showing damage ceiling and roof

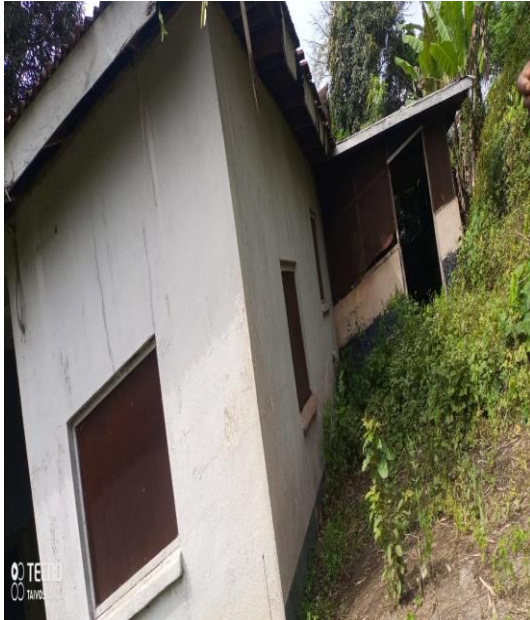
Photo 45: showing back of the residence

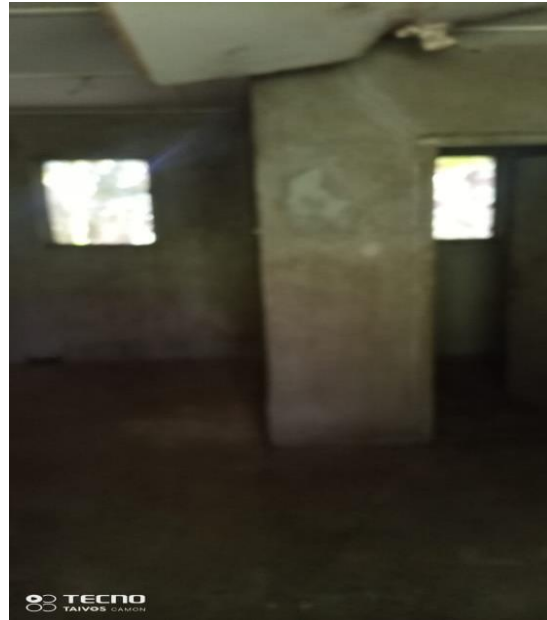
We observed that the bathroom sink, commode, face basin, wall tiles and floor tiles are poor condition, it is recommended that they be replaced. The plumbing lines and water lines need to be checked. Electrical wiring and fixtures must be checked (sockets, receptacles, switches etc.) (See Photo 39-46).

Photo 46: showing interior of residence
